Rectification of Sabah Stilt House Using Shear Wall Subjected to Earthquake

A. Rashidi^{1*}, A. A. Abdullah¹, M. I. Safawi¹, N. S. H Harith²

Abstract: A moderate earthquake with 6.0-magnitude hit Sabah in 2015 especially in Ranau, Sabah has been labelled as one of the most powerful earthquakes ever in Malaysia. Numerous buildings in Sabah have become defective with the severity level of damages as absolute (non-repairable) in the RC beam-column joints and soft-storey structures. Seismic design and construction requirements were not considered in most buildings in Sabah. Hence, this research is to investigate how to mitigate the effect of earthquake on the low-rise building using a more practical and economical method. A stilt house model is developed using ABAQUS software to determine the behaviour of the stilt, low-rise building subjected to earthquake by constructing shear wall at the short columns support. There are 4 models constructed namely, frame model without shear wall (W1), with shear wall of 100mm (W2), 300mm (W3) and 500mm (W4). The results of seismic response are evaluated and compared. Different length of shear wall affects the displacement and stress of the frame m

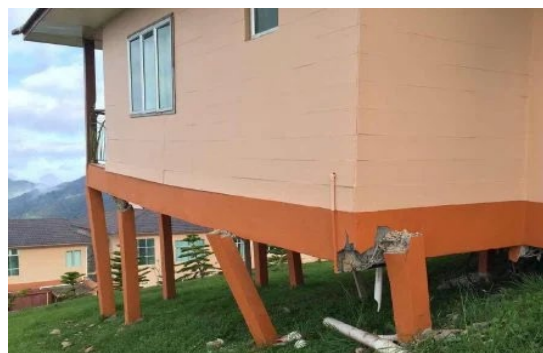
Fig. 2 shows a building on sloping ground which has suffered severe damage due to the short column failure during the Ranau earthquake. It can be observed that all the supporting columns of the building which were about 1 m long failed through shear [1], [4].

Fig. 2 - Stilt house damaged due to short column effect
