**BANK SLOUGHING AND DEPOSITION
AT AND NEAR
MOUTH OF SUNGAI BAKO**

**SUBMITTED IN PARTIAL FULFILMENT OF THE
REQUIREMENTS FOR THE DEGREE OF BACHELOR OF
ENGINEERING (HONS)**

**PROGRAMME OF CIVIL ENGINEERING
FACULTY OF ENGINEERING
UNIVERSITI MALAYSIA SARAWAK
2002**

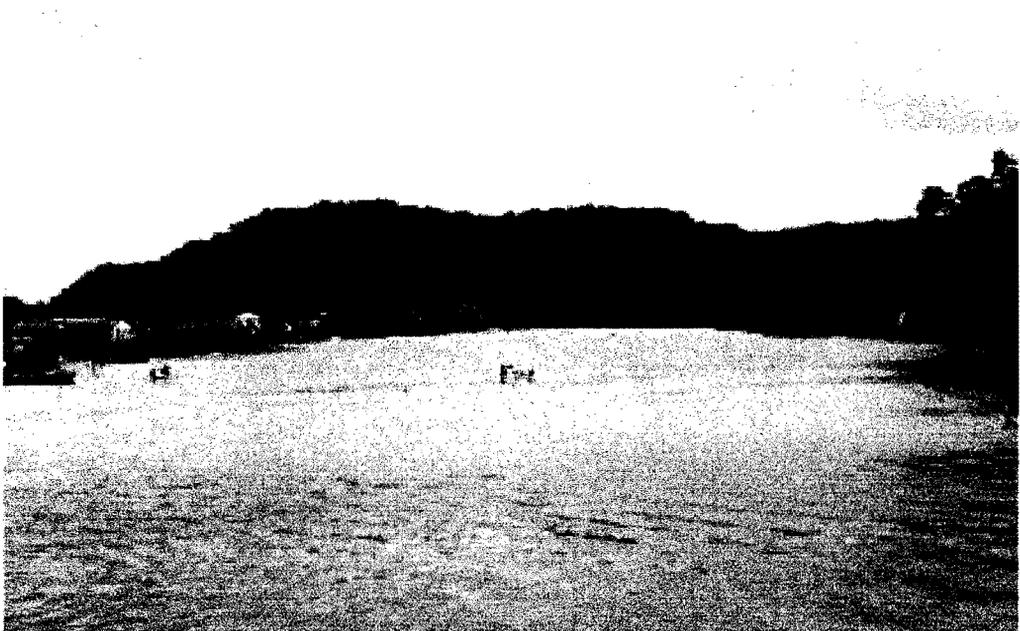
Picture 1.1a

In order to fulfill the requirement of graduation the final year students has to complete their thesis as required by the Board of the University 's Academic. As given the project is focus on the causes of riverbed deposition and riverbank sloughing upon the mouth of Bako River. The project area is covered the area of particular part (1000 meters from the mouth of the river to up-stream part) of the mouth of Sungai Bako, as in **Picture 1.1a and Map 1.1a**, just near the site of sand and gravel extraction.
