Effect of plywood retrofit on dynamic response of URM house subjected to forced vibration

2009 NZSEE
Conference

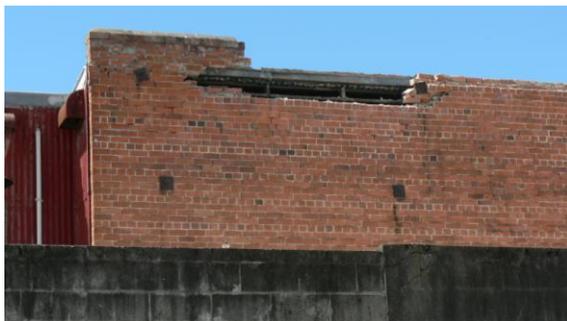
(a) Failure of wall-diaphragm tension anchor

Figure 1: Connection failures in the 2007 Gisborne earthquake

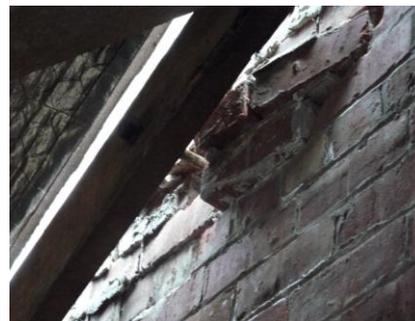
(b) Pull-of brickwork failure
