Coastal Vulnerability Assessment Along Pantai Cahaya Bulan

**Bachelor of Science with Honours
(Aquatic Resource Science and Management)**

2016

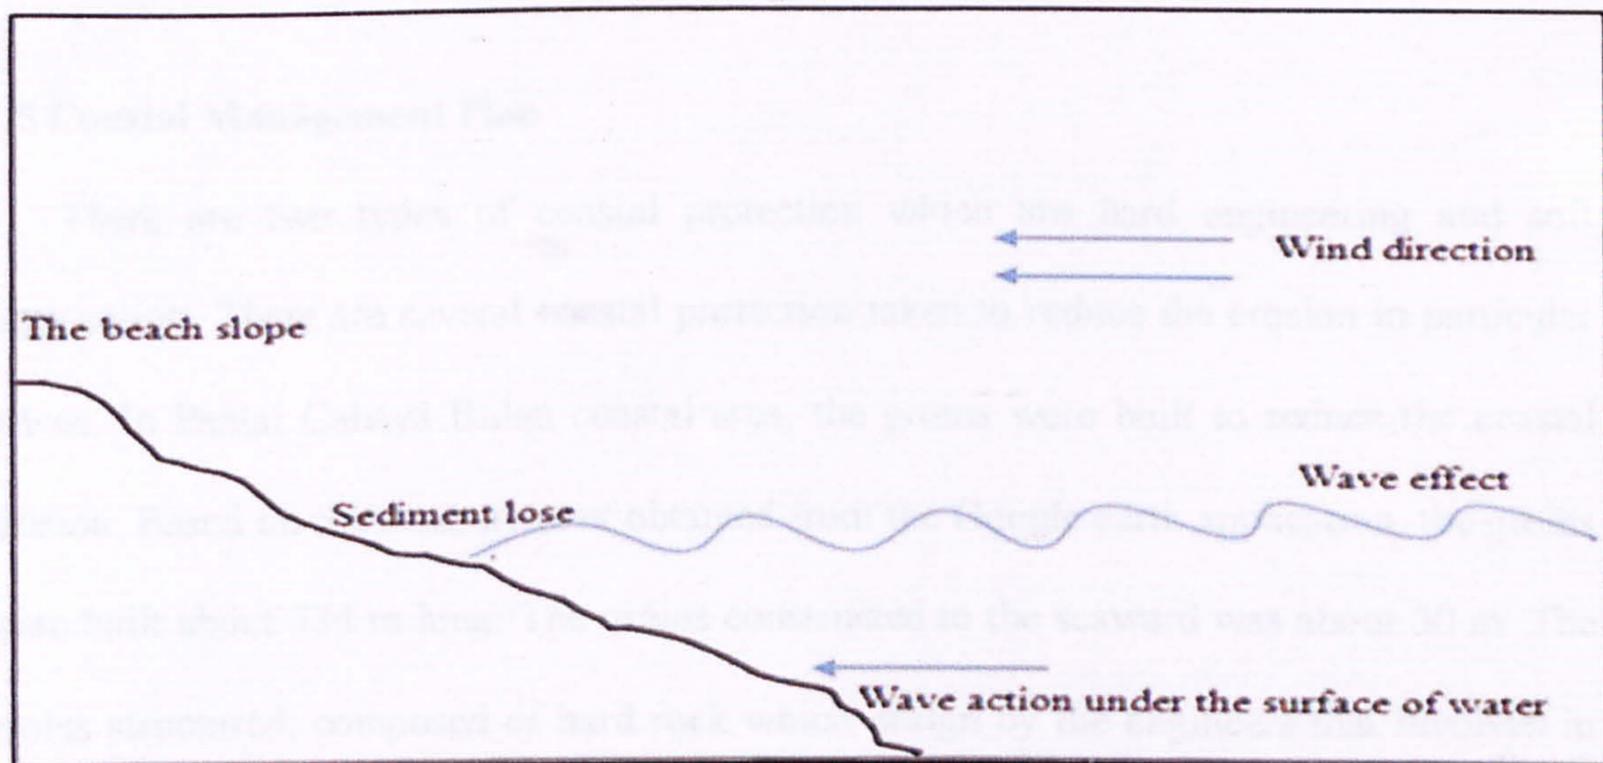
Figure 1: The illustration of wave and wind force which affect the sediments under the surface of water and the beach.

Coastal erosion can be defined as the process where shoreline undergoes some changes, especially the breakdown of the sediments and rocks in land and below water surfaces. The erosion happens as the result of wave effect and sea level rise. Coastal erosion caused the structure of the beach loose and the landward movement of the shoreline. Coastal erosion happens during the strong wind, strong wave and tidal effect. The process of coastal erosion occurs in a long time. The coastal erosion and coastal deposition may occur at the same time depending on the inputs from the river, sea level and the tectonic activities. The coastal erosion drive by hydraulic action. Water from the sea hit the rock and the surface of the sand. The wave will transport the sand away from the beach.

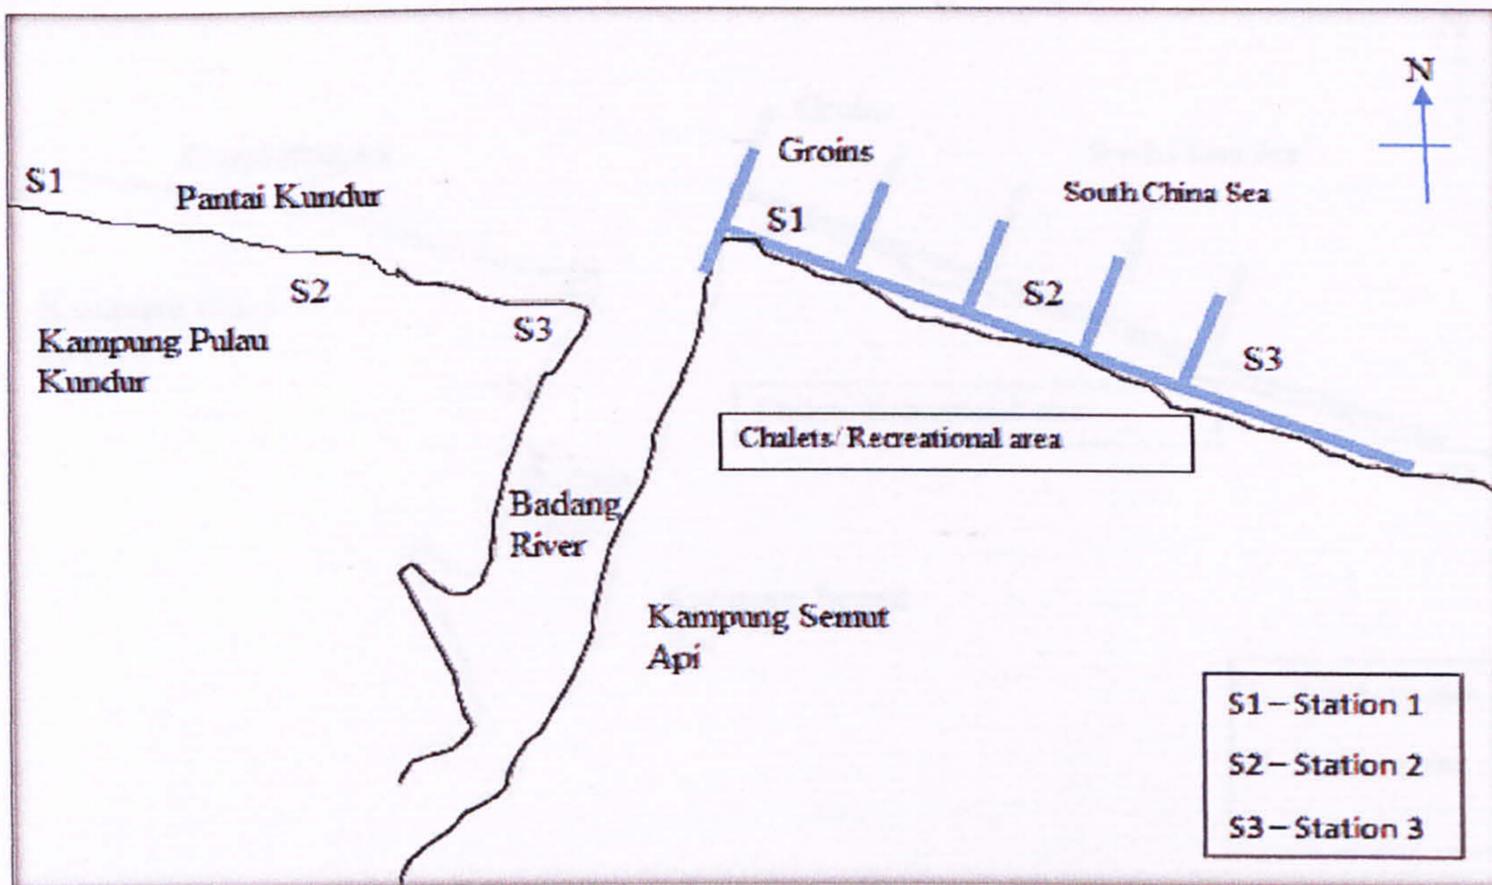
Figure 2: The study area of coastal assessment in Kota Bharu coastal area.

This study was conducted at the Kota Bharu beach in Kelantan. Three stations were set along the shoreline of Pantai Cahaya Bulan and Pantai Kundur. Pantai Cahaya Bulan was also known as a famous recreational area in Kota Bharu. Pantai Kundur located at Kampung Pulau Kundur. Badang River acts as a border between Pantai Cahaya Bulan and Pantai Kundur. The study was conducted during the early of NE monsoon (November 2015) and at the end of the NE monsoon (February 2016). The expected months for the heavy rainfall and high wave impact at Kelantan usually within November to end of March. Each beach has three stations labelled as Station 1, Station 2 and Station 3.

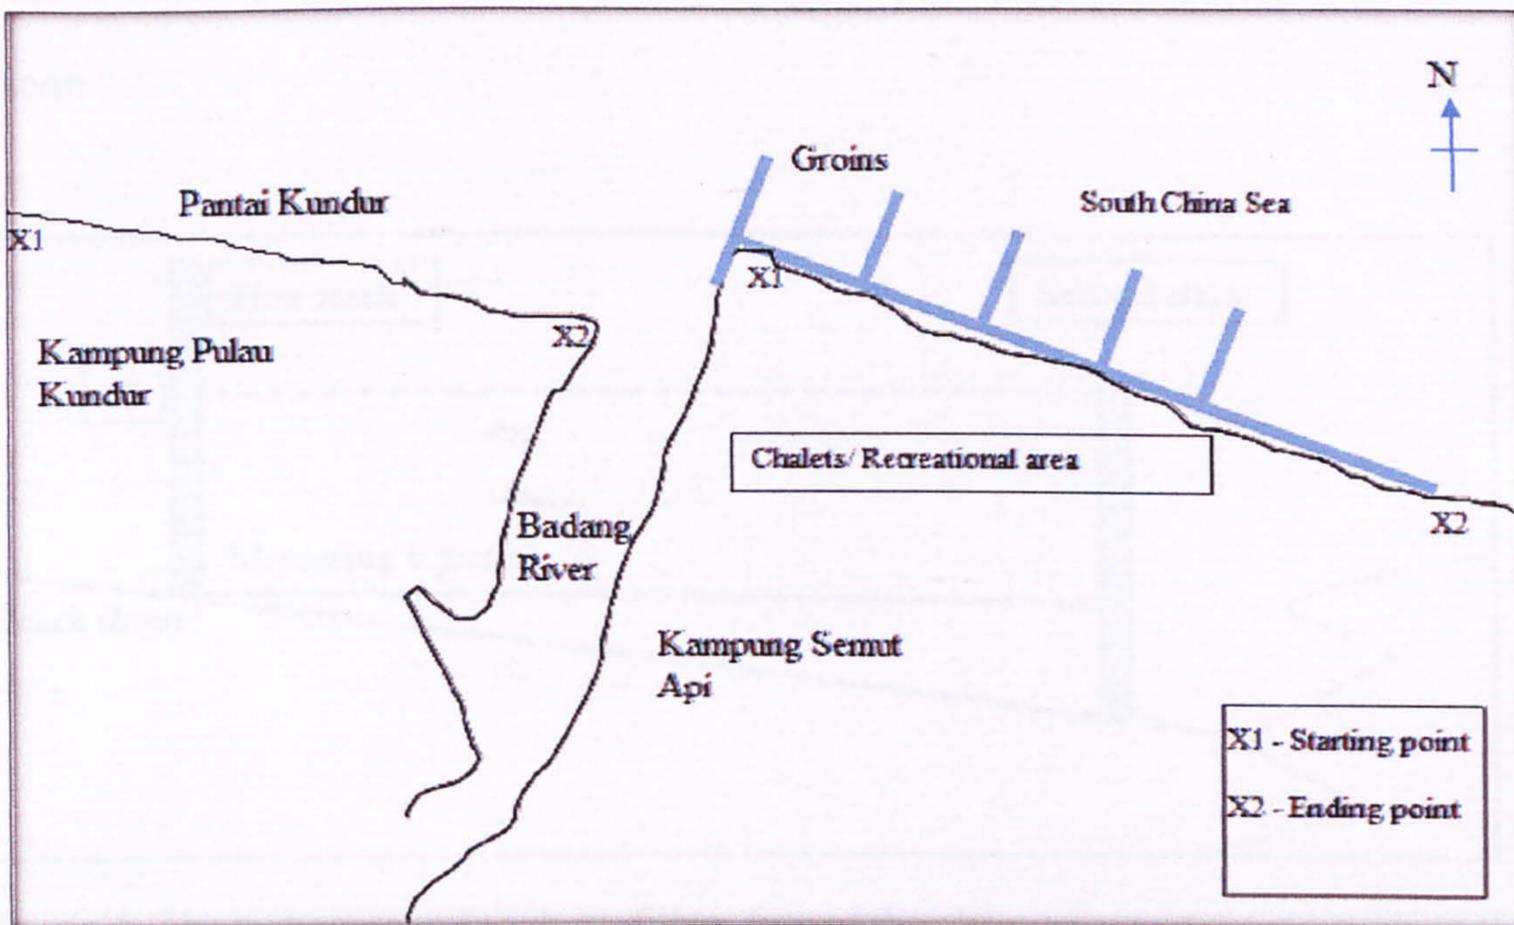
Figure 3: X1 and X2 indicates the starting and ending point for shoreline tracing in each beach.

Rate of change in the shoreline position used by the researchers for coastal planning and management (Kraus and Rosati, 1997). Shoreline tracing was used to detect the sea level rise. The shoreline tracing is important to identify the position of the current shoreline and the data can be compared with previous years by using Google earth application. The shoreline tracing technique requires Global Positioning System (GPS). At the starting point, the coordinates were recorded. For each 20 steps, the coordinates was recorded. The same steps were repeated until the last point. The total distance for shoreline tracing in each beach was about 1 km long.

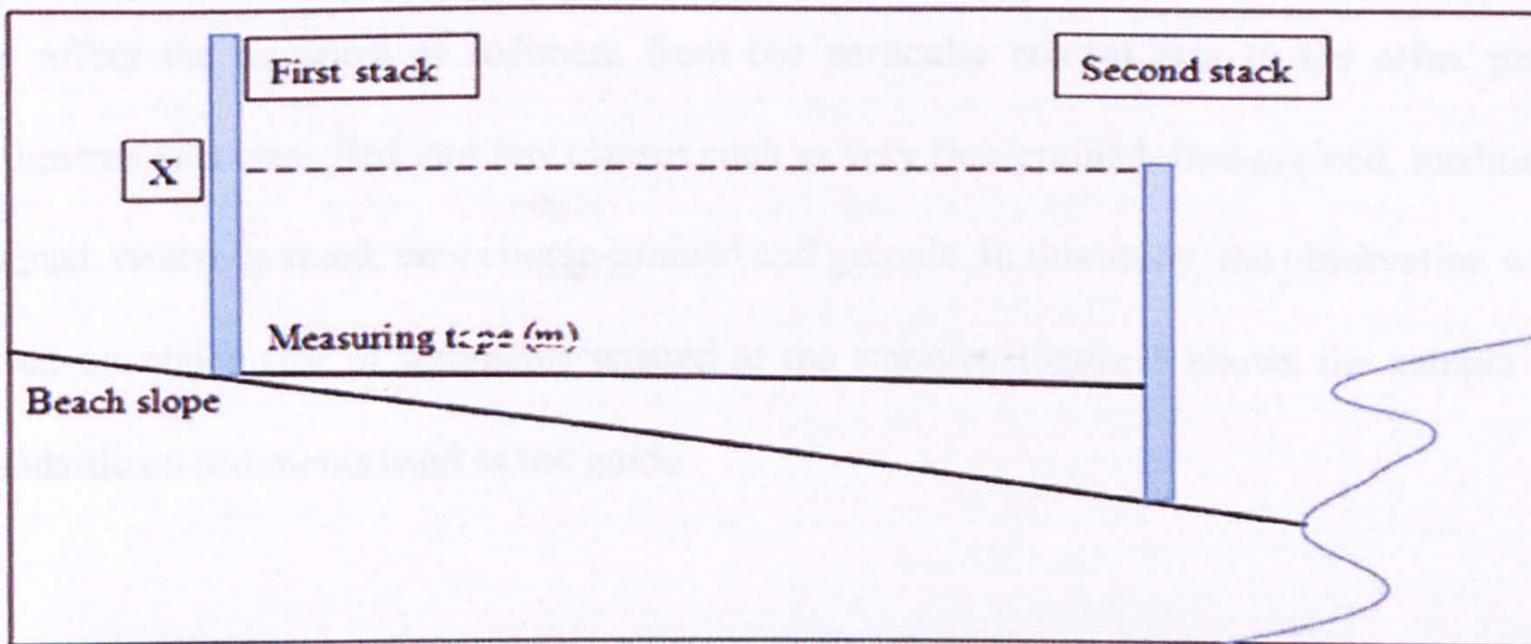
Figure 4: The technique of beach profiling. Eye of the observer was perpendicular to the horizon. Two person hold the stick and another person record the readings. The method was introduced by Emery.

Beach profiling is a method introduced by Emery to determine the difference in level along the beach profile (Andrade & Ferreira, 2006). The height or the changes of elevation of the beach was determined by beach profiling data. Beach profiling at Pantai Cahaya Bulan and Pantai Kundur was done by selecting the king tide point. By using 2 sticks with 1 meter long and measuring tape, the measurement take placed from the king tide point until the shoreline. The first stick was placed at the first point. The distance were measured about 50 meters and the second stick were placed. The reading was recorded with respect to the horizon of the sea. There were three stations of beach profiling in each beach. The data collected from the pre-NE monsoon was compared to the data obtained from the end of NE monsoon.

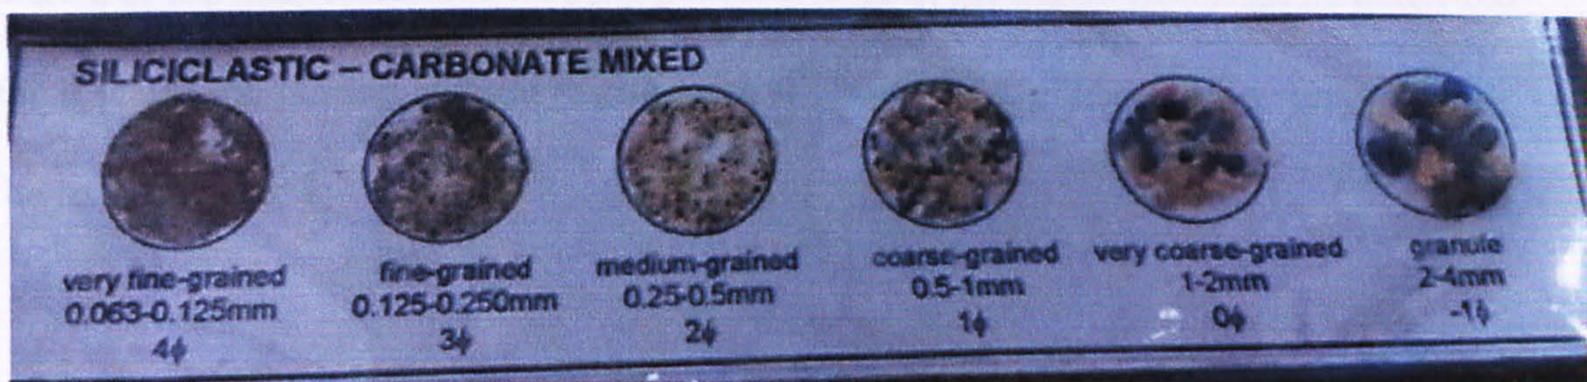
Figure 5: Siliciclastic-Carbonate Mixed used as size parameter to observed the size of the grains.

The dominant sediments was observed in each station of both Pantai Cahaya Bulan and Pantai Kundur. Sediments size is very important because the size of the sediment one of the factor that lead to accretion and erosion of the coastal area. In addition, size of sediments can affect the transport of sediment from the particular coastal area to the other part. Sediments was classified into few classes such as very fine-grained, fine-grained, medium-grained, course-grained, very course-grained and granule. In this study, the observation was based on major size of sediments existed at the stations. Figure 5 shows the sample of standardized sediments used as the guide.

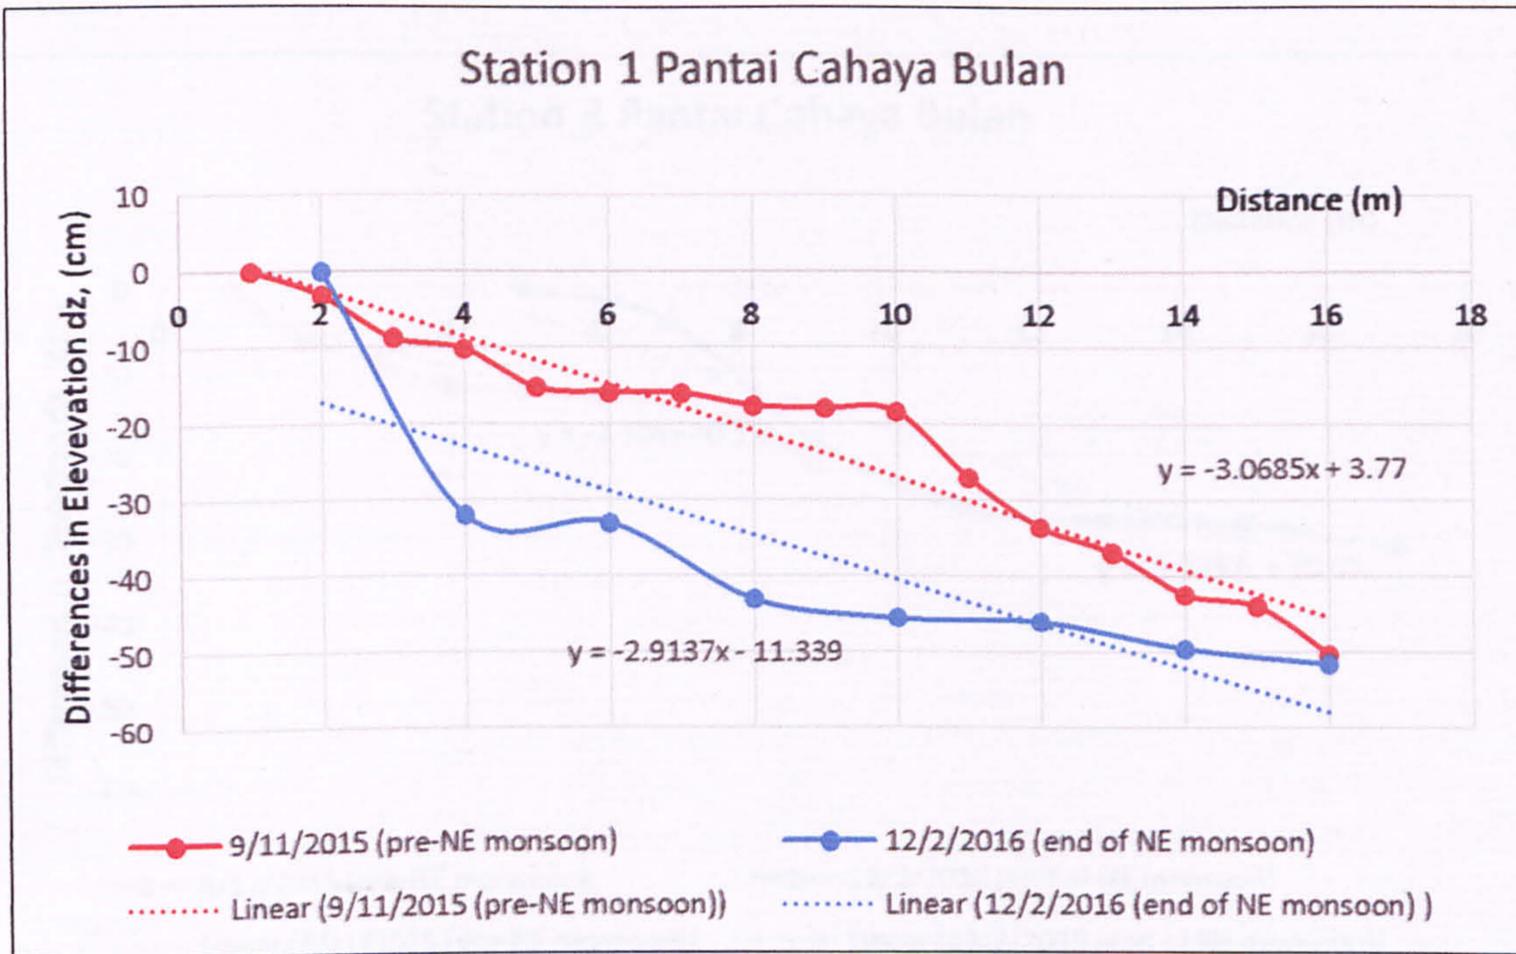
Figure 6(i): Gradient of elevation during end of NE monsoon was high than pre-NE Monsoon. The difference of gradient was about 0.1548.

Figure 6 represent the graph of the differences in elevation dz (cm) during the pre-NE monsoon and at the end of NE monsoon of Station 1 in Pantai Cahaya Bulan. Based on Figure 6(i), the red line represent pre-NE beach profile while blue line represent end of NE beach profile. The gradient of pre-NE was -3.6085 while the gradient of end NE monsoon was -2.9147. The high value of gradient show that the accretion occur at that station. The starting point of both data collection was slightly differ due to beach condition at that particular period.

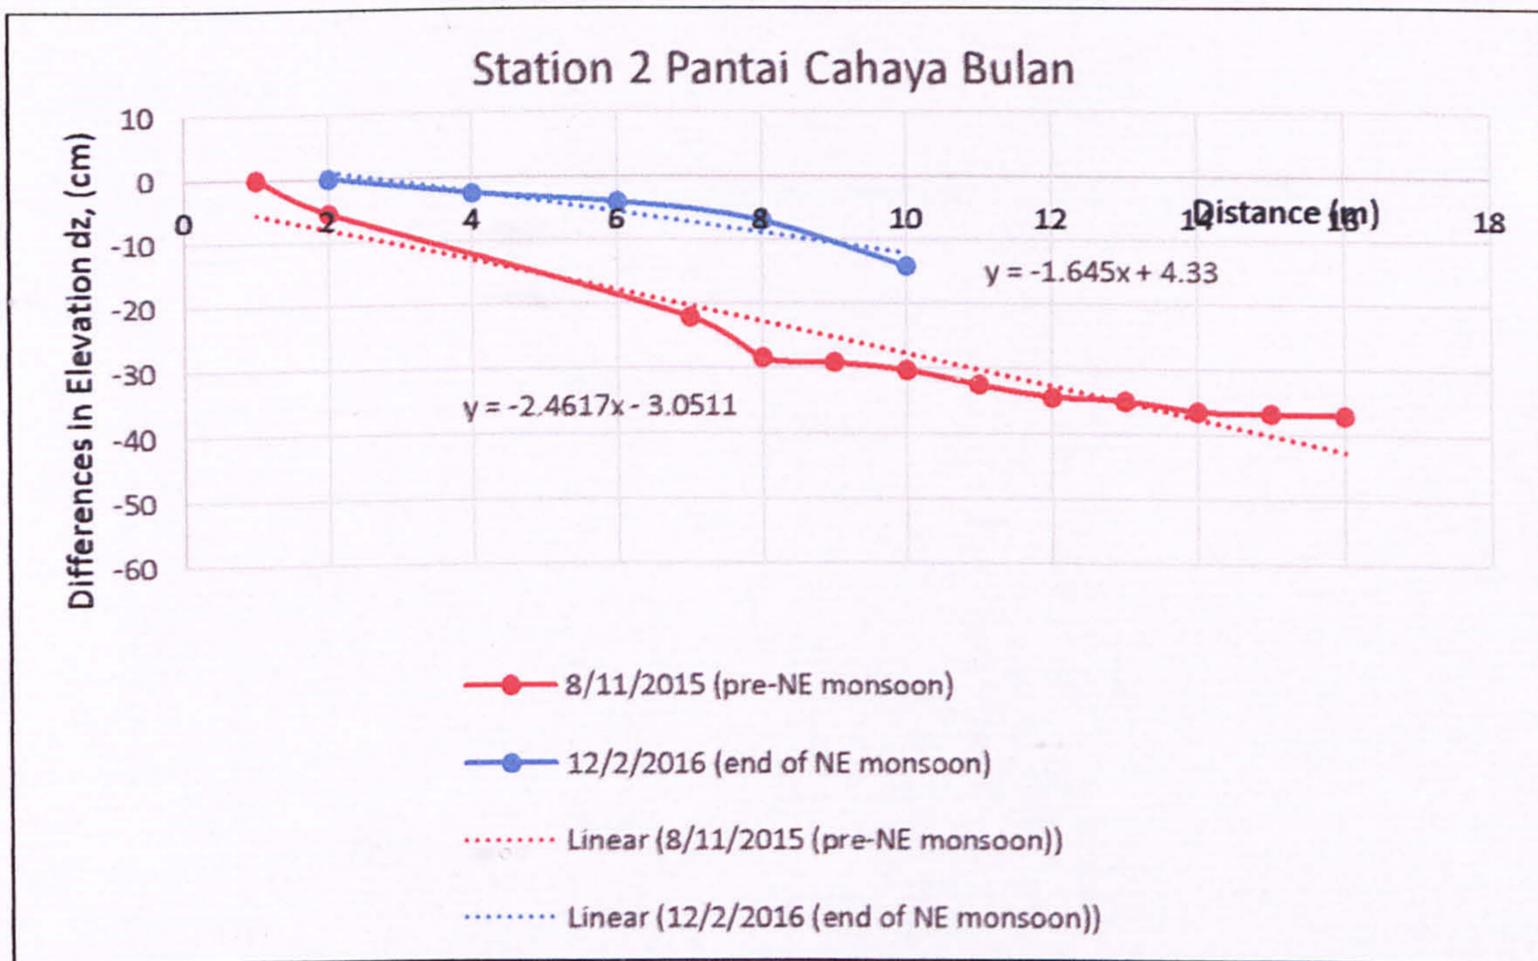
Figure 6(ii): The gradient of elevation during pre-NE monsoon was lower than end of NE monsoon. The difference of gradient was 0.8167.

Figure 6(ii) shows the difference of elevation dz (cm) at Station 2 of Pantai Cahaya Bulan. The gradient of elevation during pre-NE was -2.4617 while the value of gradient at the end of monsoon was -1.645. Based on the graph, the beach undergo accretion at Station 2.

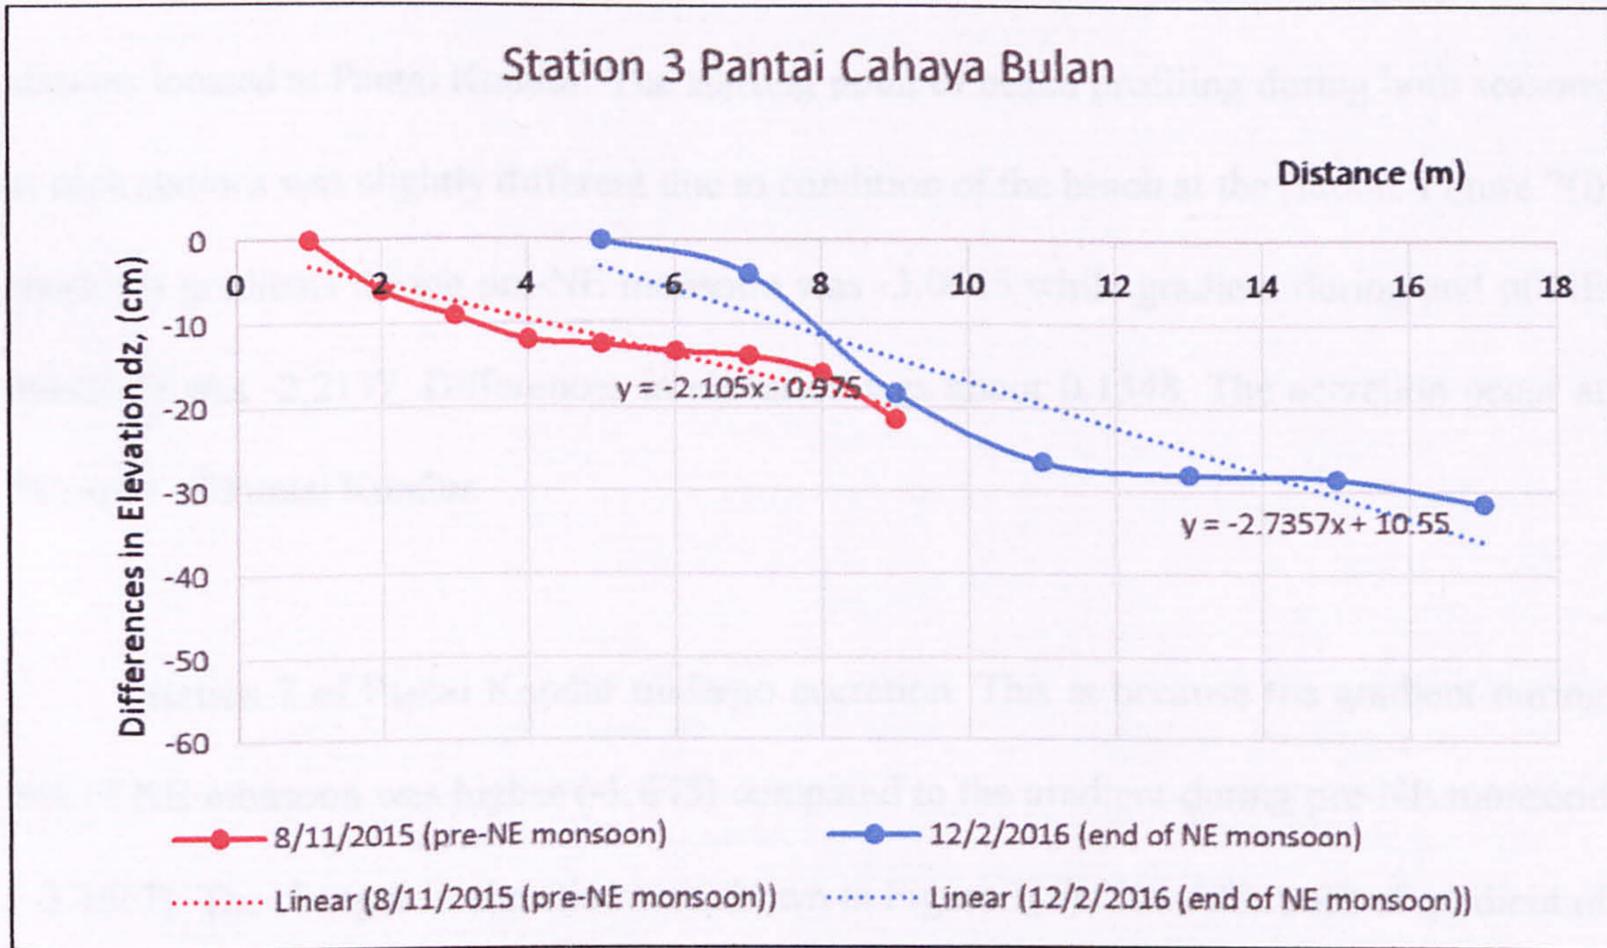
Figure 6 (iii): The gradient of pre-NE monsoon was higher than end of NE monsoon
 The difference of gradient was 0.6307.

In Station 3 of Pantai Cahaya Bulan, the seasonal erosion was occur. It was proved where the value of the gradient during pre-NE monsoon was higher compared to end of NE monsoon. The graph of elevation can be referred in Figure 6(iii).
