**Bolted Connection Design Recommendation of *Nyatoh* Hardwood for
Retrofitting the Unreinforced Masonry Buildings**

**Master of Engineering
2023**

A thesis submitted

(Department of Civil Engineering)

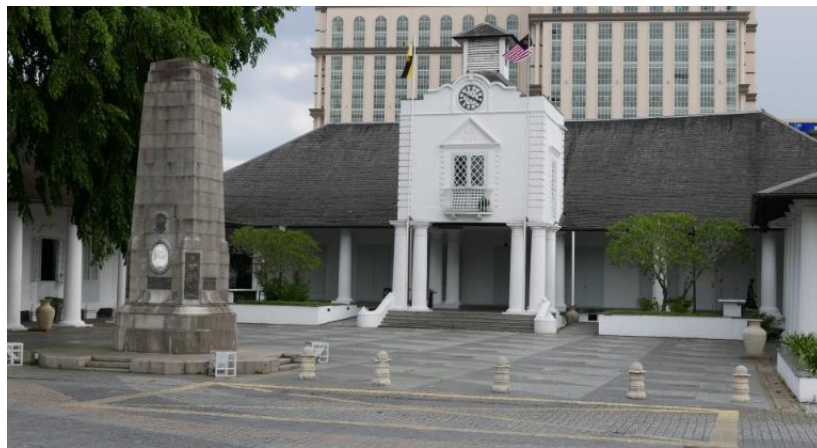
Figure 1.1: The Old Courthouse in Kuching

to serve the building as the horizontal structural element. Figure 1.1 shows the example of unreinforced masonry buildings that can be found in the Kuching City Centre. Typically, in their as built, the buildings provide no connections between the vertical and horizontal structural components, whereas the roof / floor diaphragms are found to be seated on the building perimeter walls. This significantly causes the buildings to be very vulnerable in resisting the lateral or horizontal external forces, which is predominantly induced by earthquakes. Nowadays, some of the buildings found to have wall-diaphragm connections that are found to be part of the strengthening efforts prior to lessons learned from the major earthquake events. According to Abdul Karim (2012), the major parts of the wall-diaphragm connections are divided into: (i) wall anchorages, either a through-bolt rod connected with an external wall plate, or a dowel rod drilled into the wall; and (ii) diaphragm connections, bolted connections to the timber floor joist or to the timber roof rafters.

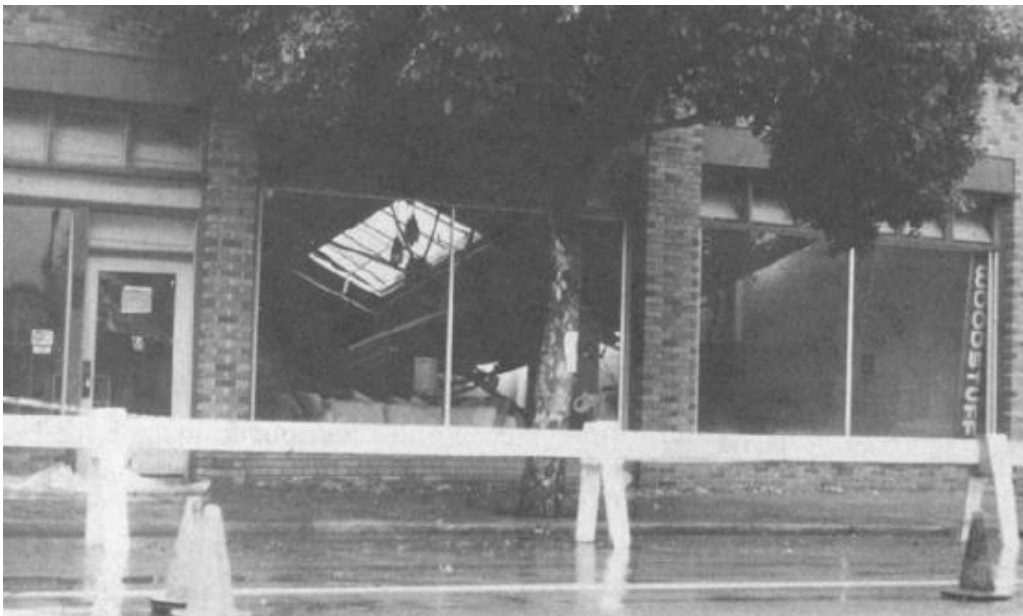
Figure 1.2: Typical Failure of Slipped Roof Joists Off Their Wall Supports (Bruneau, 1994)

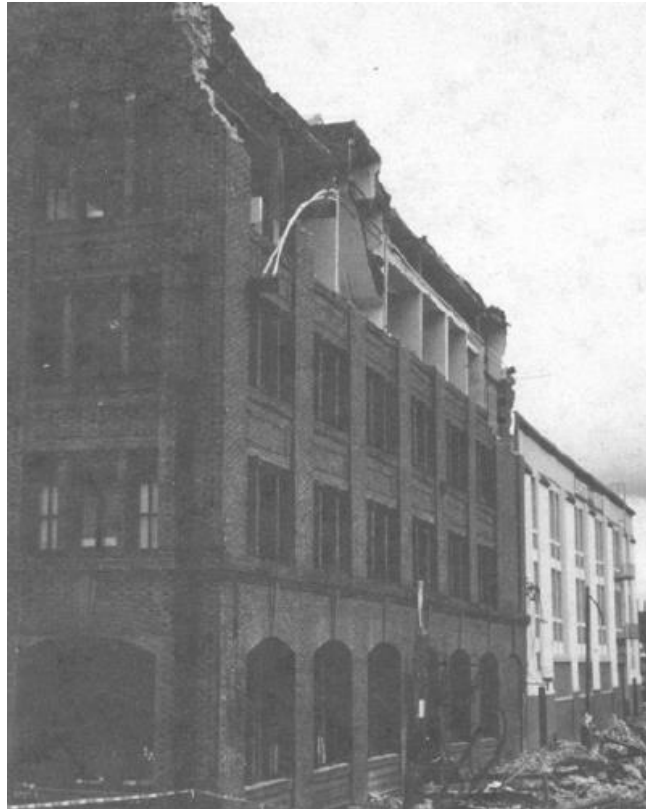
Figure 1.3: Out-Of-Plane Failure of URM Top-Storey Wall at San Francisco, Loma Prieta Earthquake (Bruneau, 1994)

Russell (2010) stated that, the masonry walls that are loaded in perpendicular direction to the wall surface is termed as out-of-plane walls. In the case of out-of-plane failures, the masonry walls can collapse either by falling outward or inward from the building perimeter. Both walls collapse can significantly claim the lives of the building occupants and even the nearby pedestrians. The greater the height of the wall, the greater the flexural stress (Bruneau, 1994). As shown in Figure 1.4, the masonry walls act as a tall cantilever wall if there are no connections between the brick walls and the timber floor diaphragms when subjected to lateral loadings (Abdul Karim, 2012). From this observation, a retrofitting of the buildings by implementing the wall-diaphragm connections are very crucial to ensure the wall to be restrained at every building floor level in order to reduce the flexural stress to the walls. Thus, this present study was primarily initiated to provide an optimised design that

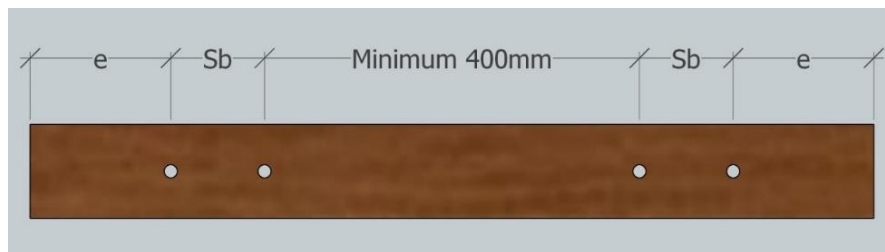
Figure 1.5: Illustration of Timber Bolted Connection Configuration Indicating The End Distance (e), and Bolt Spacing (S_b)
