# Managing condensation and mould in Malaysia

Dr Muhammad Syukri Imran Abdullah, registered professional engineer with BEM Malaysia, and Dr Khairul Azmy Kamaluddin, president of Biomedical Engineering Association of Malaysia (BEAM), look at the strategies Ministry of Health Malaysia is using to manage condensation-related mould issues in healthcare facilities, showcasing how they prioritise health and safety while navigating moisture control complexities.

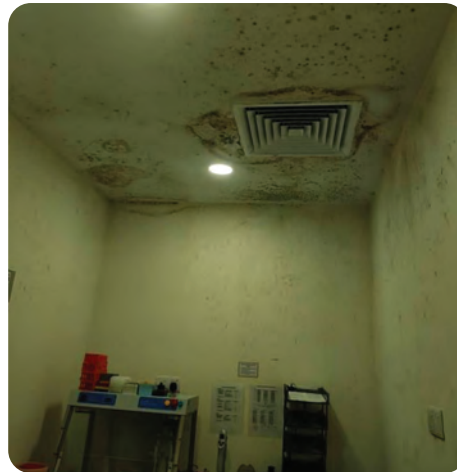
**Figure 2. Dark patches of mould growth are visible on the surfaces.**

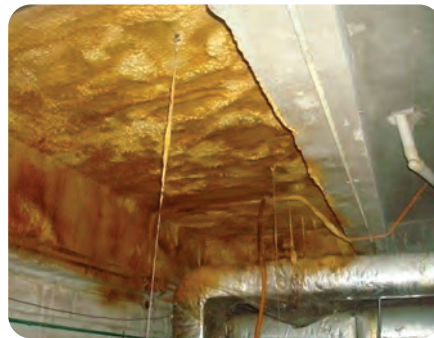
**Figure 3. Wet and saturated PU foam.**

- Wet and saturated PU foam: insufficient thickness of PU foam insulation led to wet and saturated conditions, reducing thermal performance, and potentially causing moisture-related issues (Fig 3).
- Condensation on soffit of reinforced concrete (RC) slab: a classic case at Sultan Ismail Hospital observed condensation on the soffit of an RC slab. This occurrence is attributed to the cold and uninsulated surface exposed to high humidity levels prevalent in the area (Fig 4).

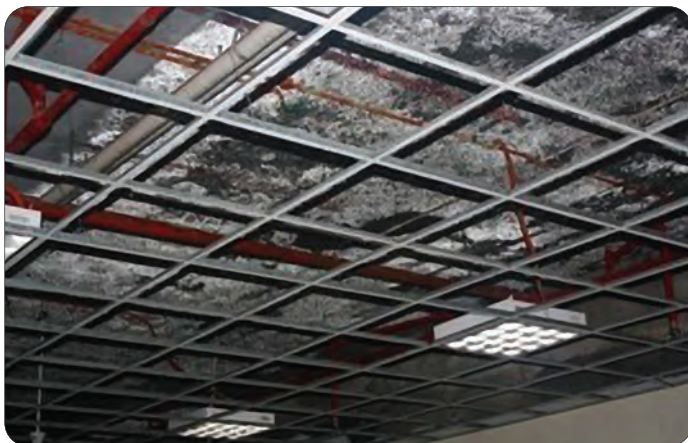
**Figure 4. Condensation on the soffit of a RC slab.**

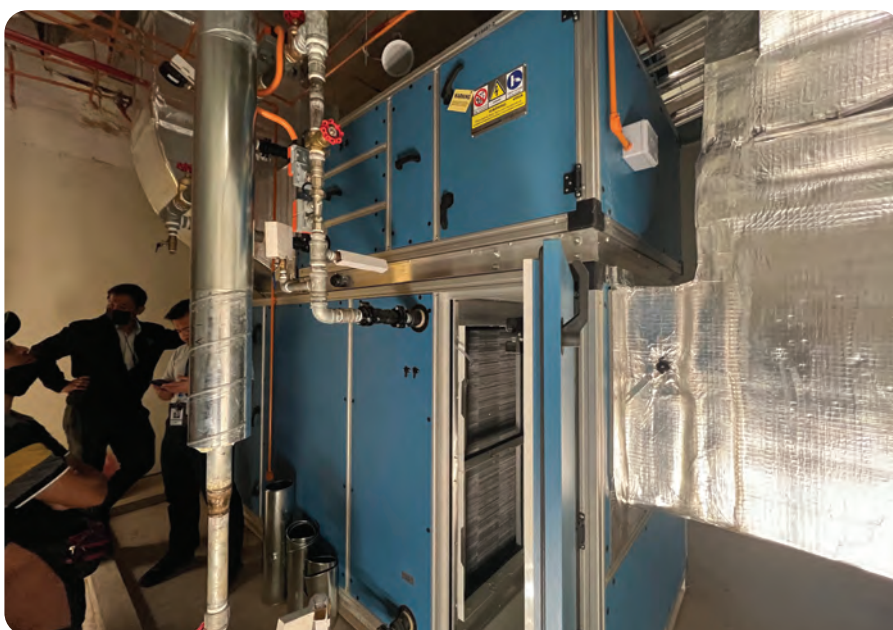
**Figure 5. A retrofit project involving the installation of a new Air Handling Unit (AHU).**

Engineers incorporate design elements to minimise moisture accumulation, including drainage systems, moisture-resistant materials, and efficient mechanical, ventilation and air conditioning (MVAC) systems. This proactive approach is exemplified in Figure 5, which shows a retrofit project involving the installation of a new Air Handling Unit (AHU) equipped with an Outdoor Air (OA) dehumidification or preheating system – in the image, the AHU is seen integrated into the existing MVAC infrastructure; this innovative addition aims to address high humidity concerns by effectively drying the incoming outdoor air before the cooling process. Figure 6 showcases a new building project using PU panel insulative

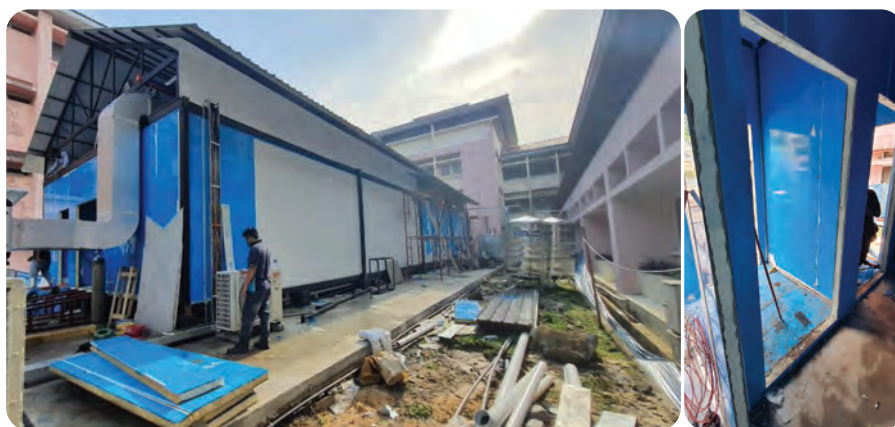
**Figure 6. PU panel insulative walls.**

walls to address heat gain, air leakage, and condensation. These panels provide thermal resistance, prevent excessive heat, and minimise air leakage for energy efficiency. Their strategic use also curbs condensation risks by maintaining balanced temperatures and reducing moisture accumulation on surfaces. Additionally, MoH invests in staff training to raise awareness of condensation and mould risks, empowering them to promptly report potential issues.
