Field Study of Riparian Zone along Sarawak River at Bintawa, Kuching

Darrien Y.S. Mah and Allan P.P. Pui

Department of Civil Engineering, Faculty of Engineering, Universiti Malaysia Sarawak

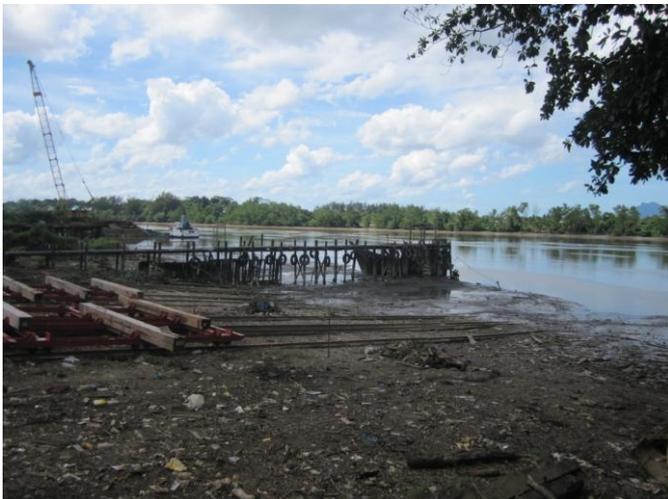
Figure 3: Jetties and Riverbank Conditions in Bintawa

Bintawa is a mixed-use area comprising factories, garages and residential houses. Most of the industrial establishments are constructed with riverside embankments and jetties along the riverbank of Sarawak River, as shown in Figure 3. These developments have negatively affected the natural riparian zone. The soil type of the riverbank is naturally peat soil. However, the construction of embankments with building materials such as concrete, stone, and timber has changed the soil characteristics.

The native vegetation consists of coconut palms, nipah palms, areca, and sago palms [8]. Most of the native vegetation has been destroyed by human activities. However, healthy small trees, shrubs and grasses are found along the riparian zone, as shown in Figure 4. These plants are periodically maintained by the City Council. The observed vegetation species are physiologically adapted to a greater amount of groundwater compared with the upland species [9],[10]. The well-being of the riparian zone is perceived to be relatively straightforward given the lushness of vegetation growth in the tropical environment, as demonstrated through the stark contrast between the bare grounds in Figure 3 and the greenery in Figure 4.

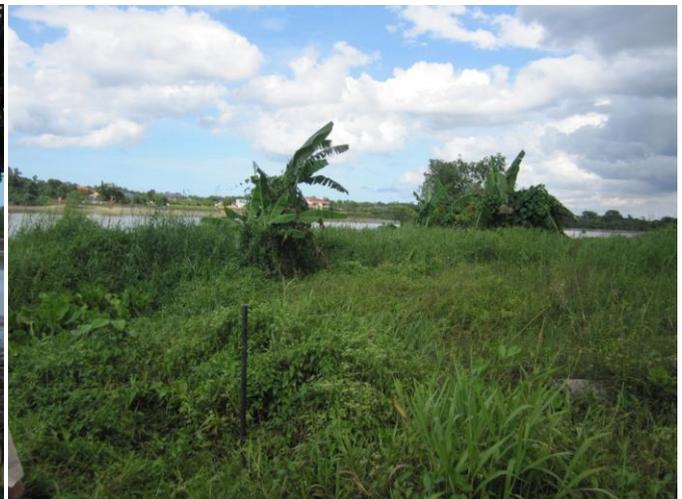
Figure 4: Common Vegetation in the Study Area
