Review of Impact of 2004 Great Sumatra-Andaman Mega Thrust Earthquake and Tsunami on Affected Countries using ECLAC DaLA Framework

Imtiyaz Akbar Najar^{*1}, Raudhah Binti Ahmadi², Nadeem Akbar Najar³, Shahana Akbar⁴, Nurul Syafiqah Binti Hanapi⁵ ¹PG Student, ²Senior Lecturer, ⁵UG Student, Department of Civil Engineering, Universiti Malaysia Sarawak,

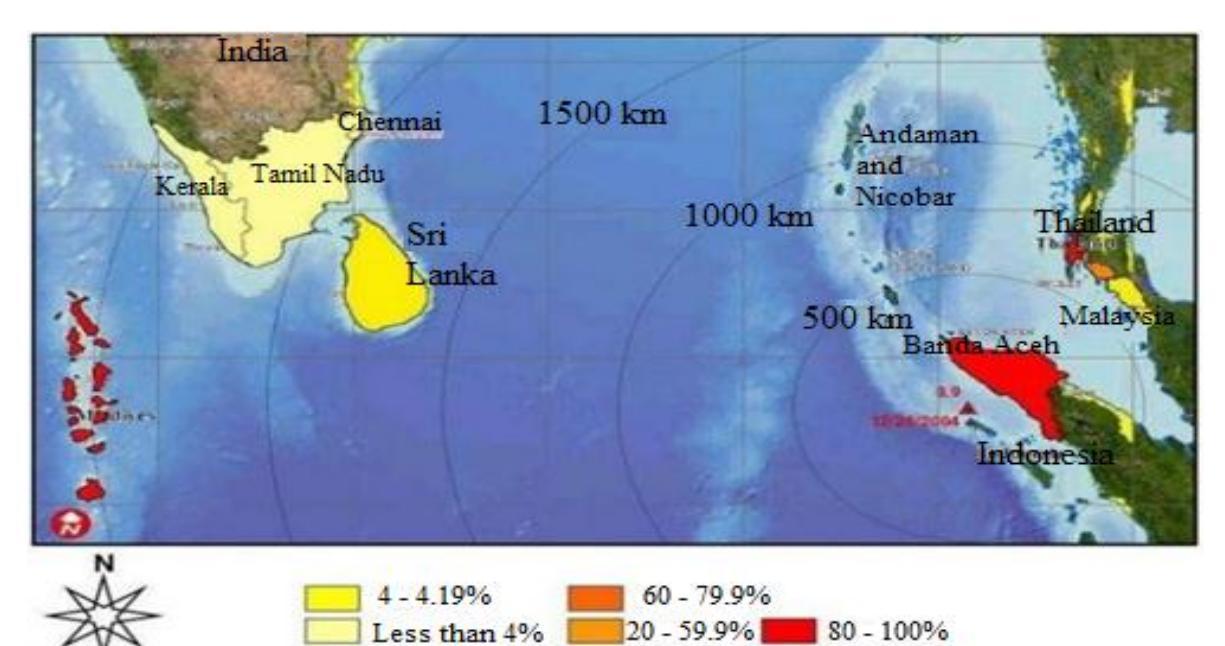
Figure 1: Country wise magnitude of the impact of tsunami [3].

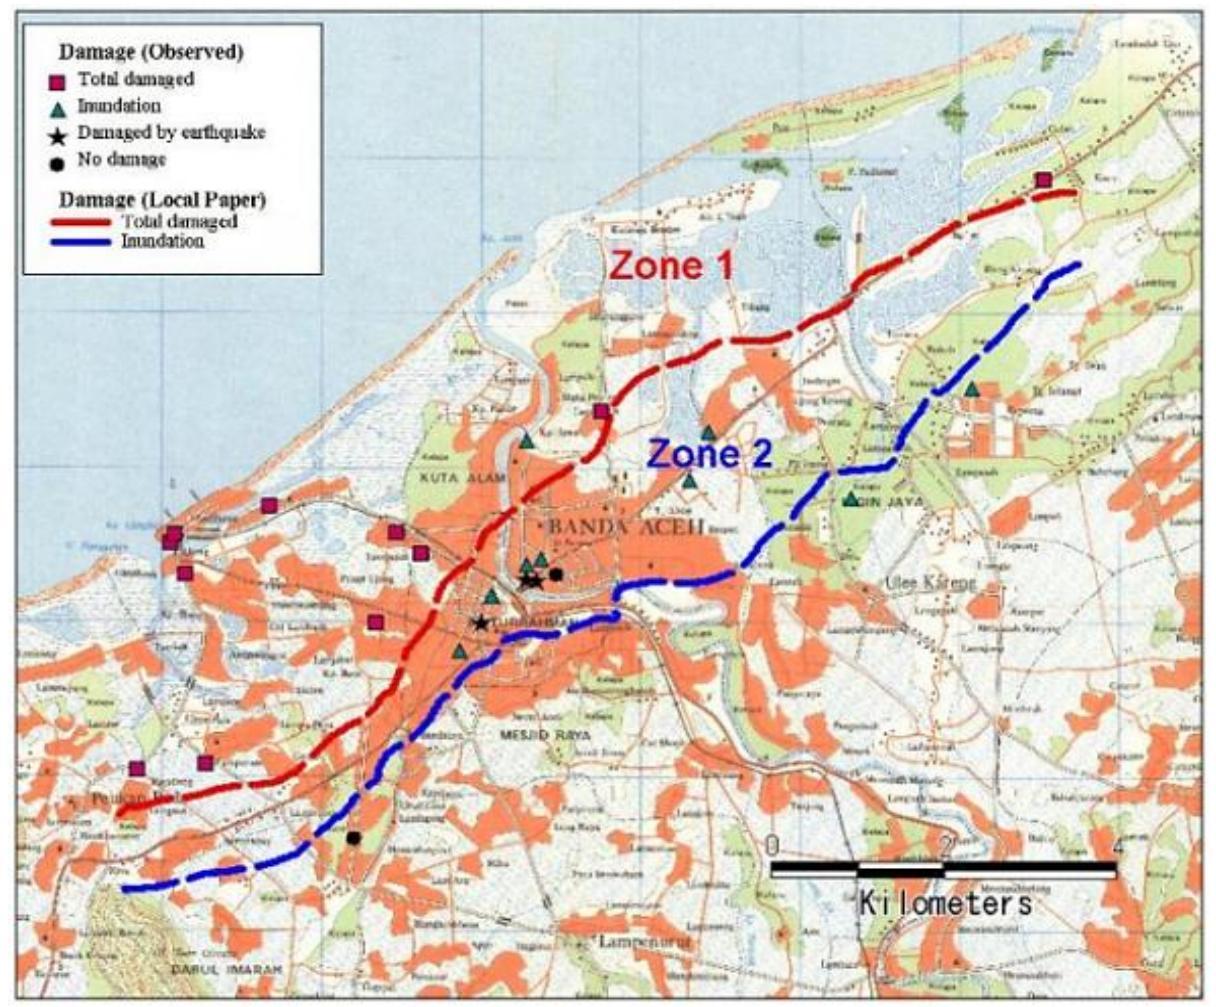
Figure 2: Flooding Zones.

Approximately after 40 minutes of the earthquake, the first tsunami wave was approaching and the people of coastal areas saw that the huge wave was approaching the coast and also the sea level was subsided from the beach. After the two waves a third strong tsunami wave came up and it destroyed the infrastructures, lives, property etc. Some people issued warnings when the first tsunami wave was approaching about the flood and started running towards the core of the city. Because of the early warning, 30% of people succeeded and survived the tsunami and the other 70% were wiped along with their houses. After this earthquake, another earthquake took place with a moment magnitude of 8.6 on 28 March 2005 near to the island. There were two zones affected by the December 2004 tsunami (Refer Fig. 2) i.e. zone 1 was the coastal area which was destructed by the tsunami forces; this zone goes up to 3 km inland.

Zone 2, this area was approximately 1.5 Km and in this zone, the tsunami forces were not much strong

and caused only flooding and dumping of mud and debris without causing serious damages.
