CHAPTER 37

WATER PERMEABILITY AND CHLORIDE AND SULPHATE RESISTANCE OF RUBBERISED FIBRE MORTAR

A. M. Mukaddas¹, F. N. A.Abd. Aziz^{2*}, N.A. Mohd. Nasir², and N. Mohamed Sutan³

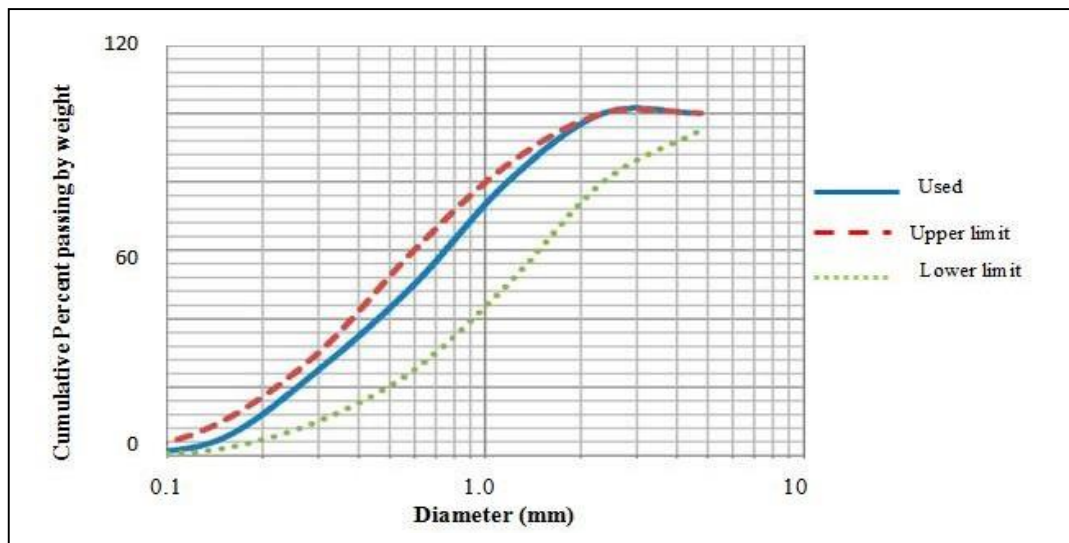
Figure 1 Combined grading for sand and crumb rubber

composite cement powder in a tilting concrete mixer until a homogeneous mix was achieved, the TCR was then air dried. The TCR was pre-treated with the aim of ensuring the existence of adequate bonding between it and other constituents, the pre-treatment with cement helps in the creation of surface roughness/friction in conformity with Farah et al. [15]. Cement was chosen because it provides better effect over other chemicals such as hydrochloric acid and sodium hydroxide etc. which could be detrimental to the cement mortar matrix. Combined grading for the fine aggregate and granulated TCR is shown as upper and lower limits and used, respectively in Figure 1. The OPFF was obtained from Seri Ulu Langat Palm Oil Mill Sdn. Bhd at Dengkil, Malaysia.

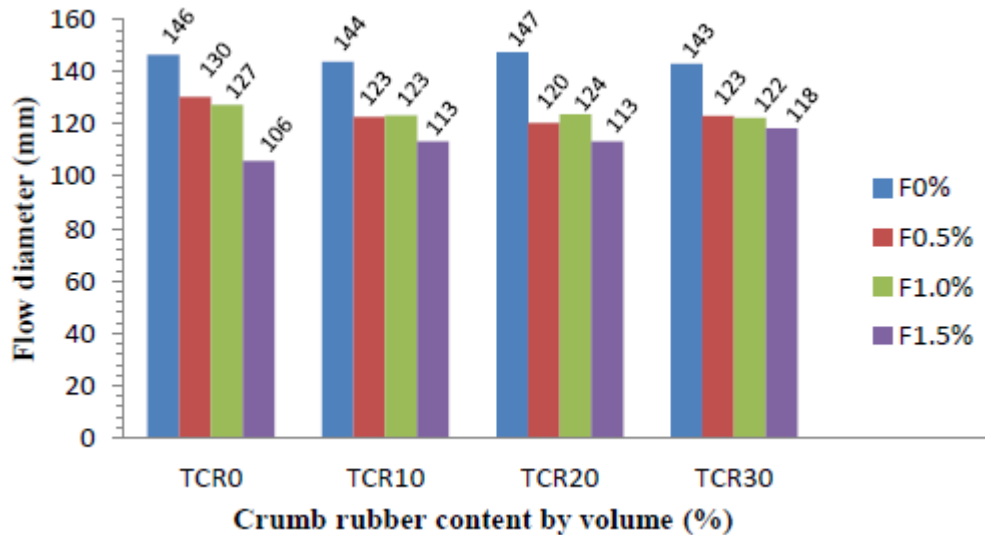
Figure 2 Workability of RFM as a function of rubber and oil palm fiber content

The important behavior for an acceptance of any waste materials used in concrete or mortar is its workability. The results for the RFM flow table test were compared to control as shown in Figure 2. The workability of TCR samples reveals the largest flow diameter of 143 - 147 mm, which is similar to the control samples of 146 mm. These show the nature of TCR, which is a non-absorbent had been improved by the cement coating treatment, which had successfully reduced the non-absorbent nature and allowing water to flow in-between its grain. Indeed, this is in line with findings reported by Gupta, Chaudhary, & Sharma [30]. With addition of OPFF, RFM mixes obtained the lowest workability with flow diameter of 106 mm. The physical characteristic of OPFF that had high water absorption capacity may affect the friction between solid particles [31], hence less water shared by other matrix and subsequently reduced the workability to about 38% of the control specimen.

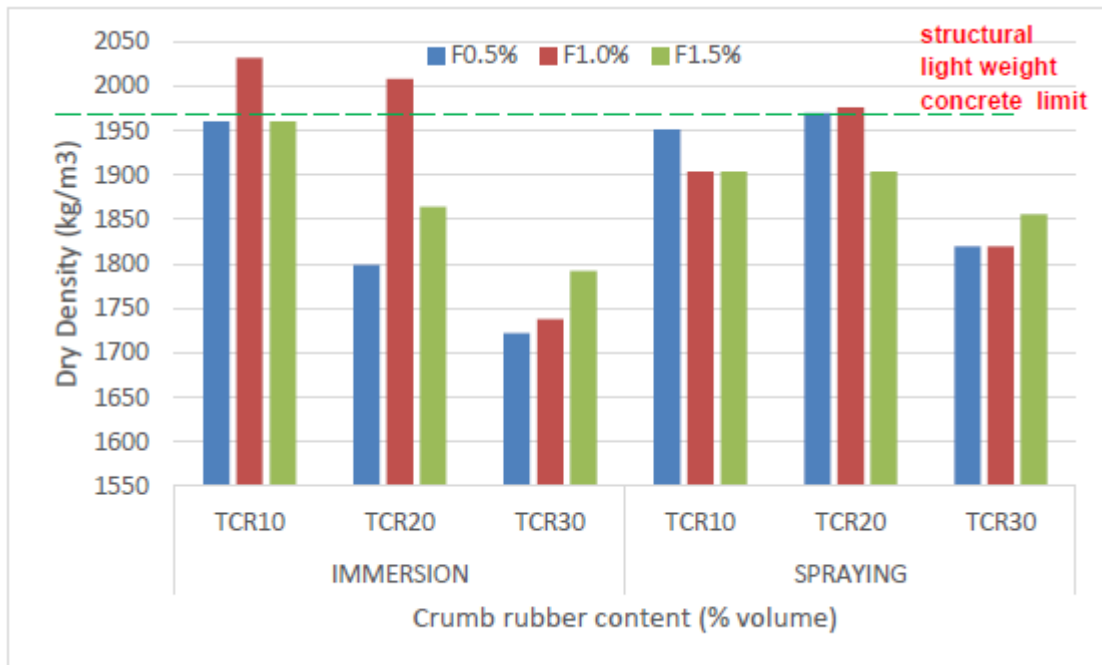
Figure 3 Density of RFM specimens

Aggregates both, fine and coarse are about 75% of the concrete density, hence their replacement with low density material will greatly result in the self-weight reduction of the concrete elements. The TCR utilised in this study has density of 688kg/m³ which is similar to that of Pierce and Blackwell [4] and Benazzouk et al. [17]. The density results for RFM specimens cured by water immersion and spraying are presented in Figure 3(a) and in Figure 3(b), respectively, where all are above 1350 kg/m³. Generally, both curing methods showed density decreases with addition of both TCR and OPFF. The low unit weight of TCR leads to the development of a lighter mortar. The density of all the specimens containing 30% TCR and 0% - 1.5% of OPFF falls within the density for structural lightweight concrete as in Table 2 except specimen containing 20% TCR and 1.0% OPFF which had 5.6% greater than the maximum value for structural lightweight concrete category. Only RFM containing 10% TCR ranged between 1960- 2128Kg/m³ which is above 1900 Kg/m³ i.e. normal weight concrete.

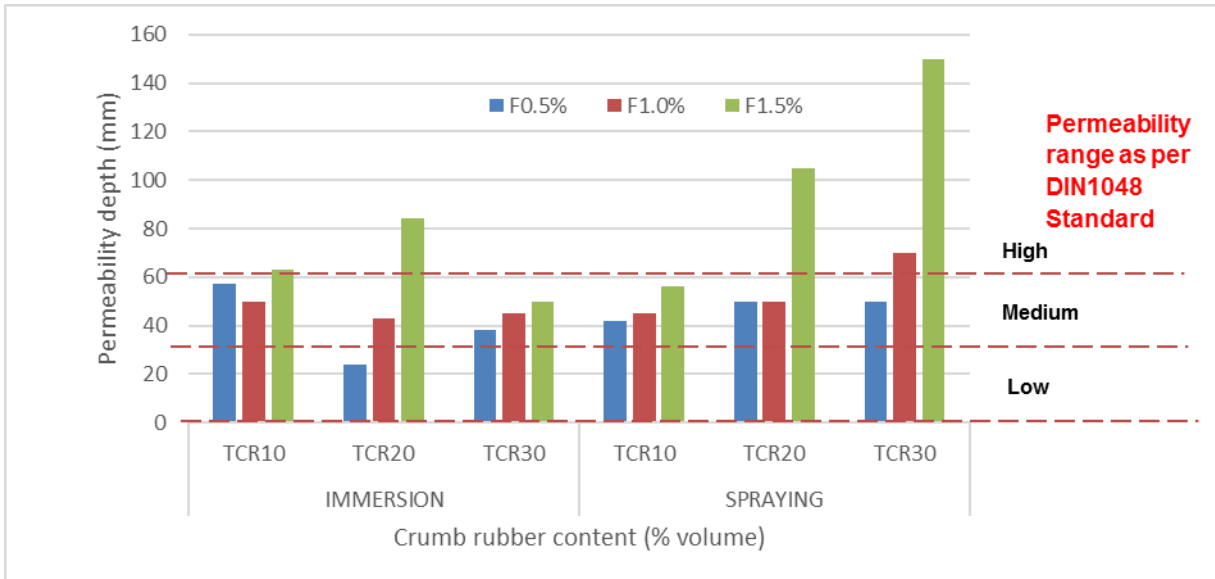
Figure 4 Water penetration depth of RFM samples

The durability of concrete is mainly dependent on the fluid ability to penetrate the concrete microstructure, which is referred as permeability or, more importantly penetrability. The permeability results of RFM are shown in terms of water penetration depth in Figure 4 and are compared to the water permeability classification in accordance with DIN 1048[33]. General observation shows spraying curing method cause higher permeability than immersion. Also based on the specimen density, the immersion cured samples (2128 kg/m³) are less porous than spraying specimens (2048 kg/m³). This shows that the earlier curing method allows full hydration of sample and subsequently produced a denser specimen, hence prevent less penetration of water.

Referring to Figure 4, an increase of TCR replacement from 10 to 30 percent cause inconsistent permeability depth on immersion samples, while spraying samples shown medium depth for 10 and 20 % TCR replacement but very high when 30% replacement is made. This is due to lack of good bonding between rubber particles and cement paste where the interface surface between cement paste and rubber grains act as the bedding for pressurised water to flow in the concrete containing rubber [11]. Similar patterns were observed when 0.5 to 1.5% OPFF are added, with the highest permeability depth is when 1.5% OPFF is added. From these results, it can be concluded that when 1.5% OPFF and 20-30% TCR are added, RFM produce a porous mortar which allows high water penetration, and when 0.5-1% OPFF with 10% TCR are used, RFM with medium penetration is obtained.

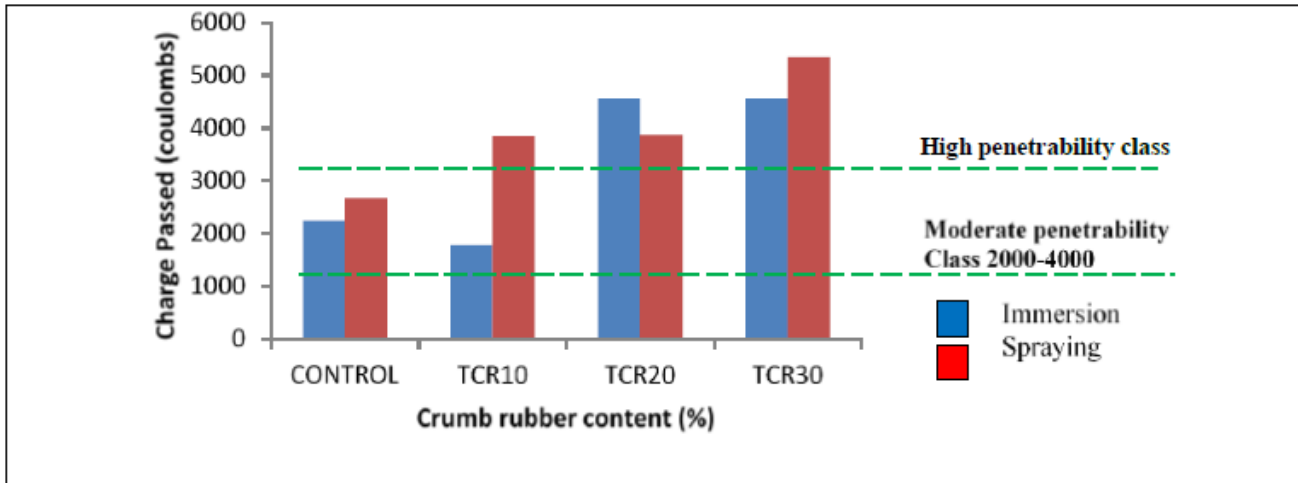
Figure 5 TRC effect on Chloride-ion penetration

Chloride-induced corrosion of reinforcing steel due to chloride ingress is the most common environmental attack that leads to the deterioration of concrete structures. The ease with which the mortar allows charge to pass through it gives an indication of the mortar's resistance to chloride-ion penetration. The effect of TRC on the chloride-ion penetration of the specimens is as shown in Figure 5. The resistance to chloride ion penetration of RFM specimens made of 10% TRC and subjected to immersion curing is better than the control specimens. This is probably due to good interaction between rubber particles and mortar composites preventing the chloride penetration to about 30% less than the control. However, as the rubber content increases, the penetration of chloride ions also increases. This is in contrast to other works reported in [34], in which the percentage of TRC is not more than 15%. This shows that addition of more than 15% TCR replacement will cause many pores and weak bond between particles in the mix, which allows high charge to pass through the mix and lowers the mix resistance to chloride attack.

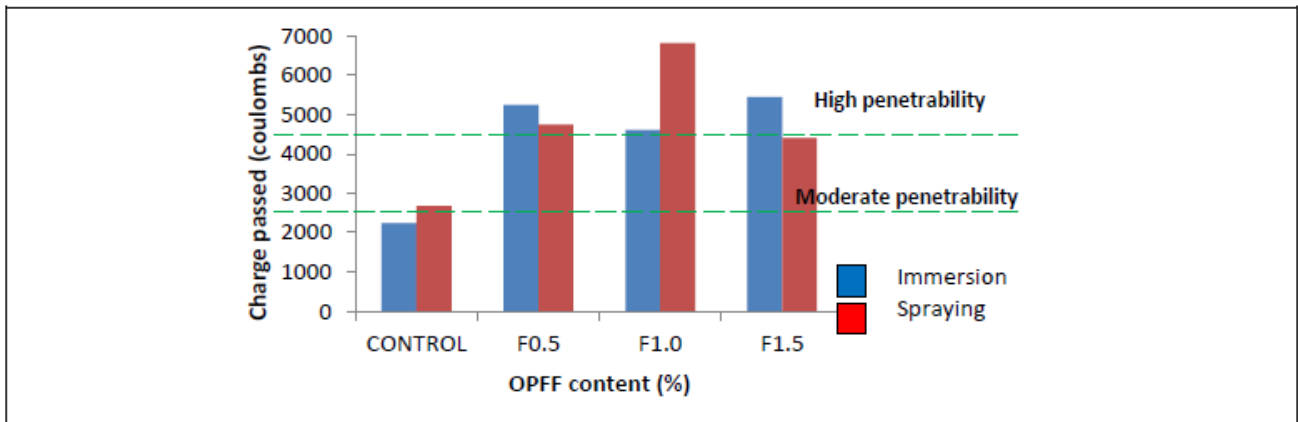
Figure 6 OPFF effect in Chloride-ion penetration

On the other hand, regardless of the curing methods, the addition of OPFF at 0.5-1.5% as shown in Figure 6 has categorized the mixes as high penetrability where the charge passed is more than 4000 coulombs. High absorption capacity of the OPFF has significantly caused large chloride penetration into the mixes. Hence, even the mechanical properties of RFM with OPFF addition show acceptable strength as reported by Aziz et al. [16], OPFF addition in the mix is not recommended when durability is the main concern. In conclusion, only 10% TCR replacement subjected to immersion curing is classified as moderate penetrability of chloride by ASTM C1202 [26], that is suitable for reinforced concrete application as low chloride-ion permeability is necessary to reduce the potential for corrosion of embedded reinforcement.

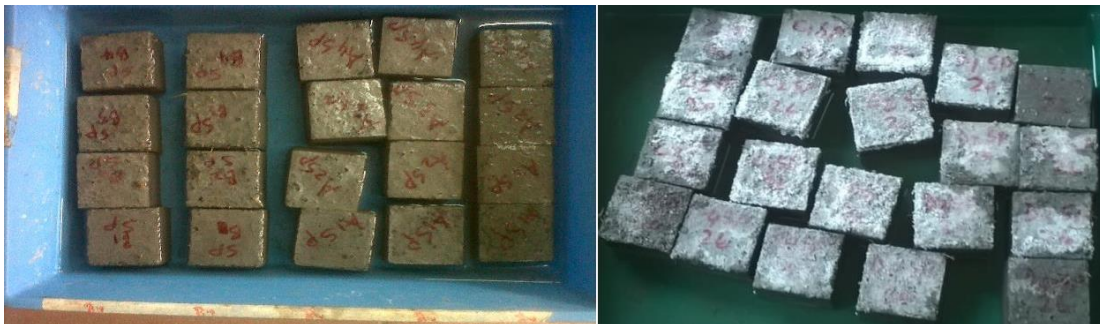
Figure 7 Salt scaling on samples surface before and after Na₂SO₄ immersion

In total 192 cube specimens are prepared, in which half were cured by immersion and another half by water spraying for 28 days before being submerged in the Na₂SO₄ solution. The average compressive strength of immersion and spraying samples are tabulated in Table 3a and Table 3b, respectively. By observation, no eroded residues of either fine aggregate or crumb rubber particles or cement were observed before 56 days, however after that, salt scaling precipitate was noticed as shown in Figure 7.
